# Access Compliance Report Public Rights-of-Way (Curb Ramps)

Main Street: DONNIS\_RD Cross Street: HEDWIG\_RD Location: NE

ADA ID: RPRK220217164506 Ramp Type: Type 1 - Perpendicular Diagonal Initial Pass/Fail: Pass Overall Compliance: No Severity Score: 14

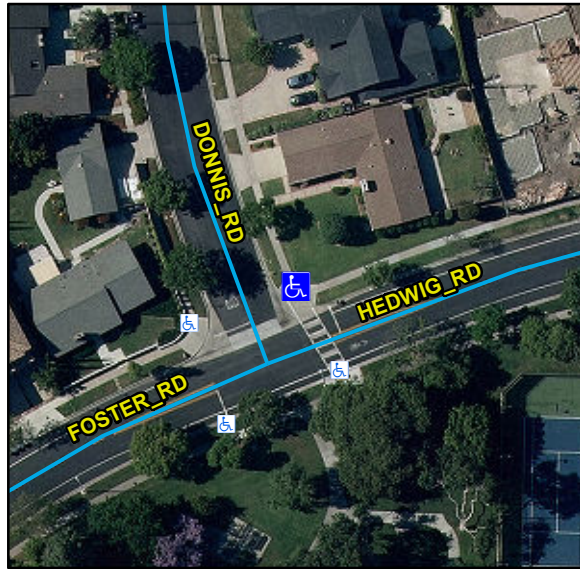
| Compliance | Description | Data | Compliance | Description | Data |
|---|---|---|---|---|---|
| Yes | Landing Cross Slope (%) | 0.4 | No | DWS Provided | No |
| Yes | Overall Surface Condition: Acceptable | | No | Perp Joint Present | No |

Remove & Replace Curb Ramp With Two New Directional Ramps or Equivalent.

R204.3, R304.2.1, R305, STD 1115
