# Access Compliance Report Public Rights-of-Way (Curb Ramps)

Main Street: FOSTER\_RD Cross Street: DONNIS\_RD Location: NW

ADA ID: RPRK220217165000 Ramp Type: Type 4 - Parallel Initial Pass/Fail: Fail Overall Compliance: No Severity Score: 2

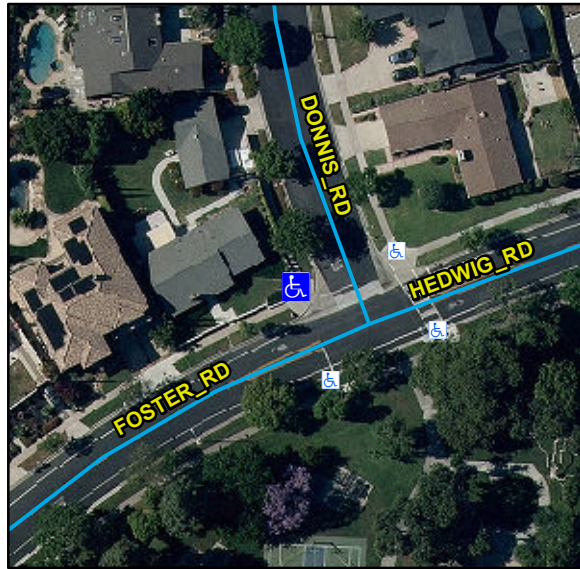
| Compliance | Description | Data | Compliance | Description | Data |
|---|---|---|---|---|---|
| No | Ramp Cross Slope LT (%) | 4.8 | No | Ramp Cross Slope RT (%) | 3.9 |

Remove & Replace Curb Ramp With Two New Directional Ramps or Equivalent.

R204.3, R304.5.3, STD 1115

Total Cost: \$ 4000
