# Access Compliance Report Public Rights-of-Way (Curb Ramps)

Main Street: DONNIS\_RD Cross Street: DONNIE\_ANN\_RD Location: SW

ADA ID: RPRK220217171749 Ramp Type: Type 1 - Perpendicular Diagonal Initial Pass/Fail: Pass Overall Compliance: No Severity Score: 12

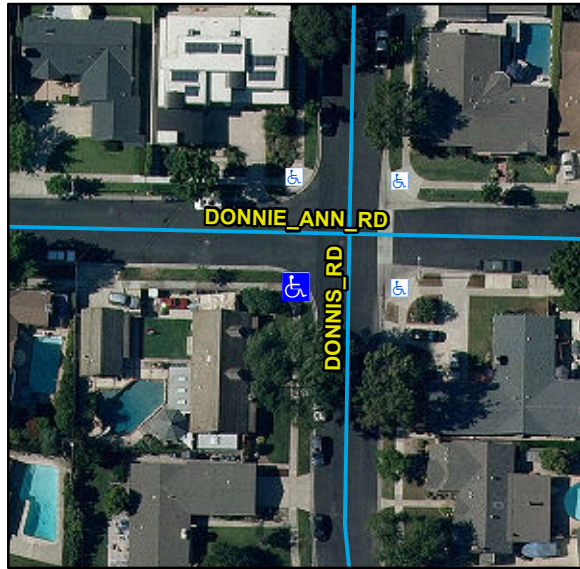
| Compliance | Description | Data | Compliance | Description | Data |
|---|---|---|---|---|---|
| Yes | Ramp Run Slope (%) | 7.4 | N/A | Flare Slope LT (%) | 8.3 |
| Yes | Landing Width (in) | 48 | N/A | Flare Slope RT (%) | 9.6 |
| Yes | Landing Cross Slope (%) | 1.5 | No | DWS Provided | No |

Remove & Replace Curb Ramp With Two New Directional Ramps or Equivalent.

R204.3, R305, STD 1115
