# Access Compliance Report Public Rights-of-Way (Curb Ramps)

Main Street: **DONNIE\_ANN\_RD** Cross Street: **DONNIS\_RD** Location: **NW**

ADA ID: **RPRK220217172305** Ramp Type: **Type 1 - Perpendicular Diagonal Initial Pass/Fail: Pass** Overall Compliance: **No** Severity Score: **15**

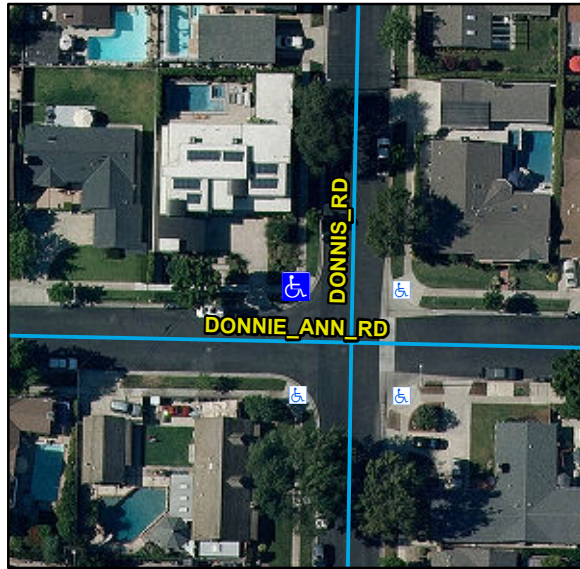
| Compliance | Description | Data | Compliance | Description | Data |
|---|---|---|---|---|---|
| Yes | Landing Cross Slope (%) | 0.1 | No | DWS Provided | No |
| No | Gutter Ponding | Yes | Yes | Curb Slope | 0.9 |
| No | Gutter Run Slope (%) | 5.3 | | Road Cross Slope (%) | 6 |

**Remove & Replace Curb Ramp With Two New Directional Ramps or Equivalent. Remove & Replace Gutter.**
