# Access Compliance Report Public Rights-of-Way (Curb Ramps)

Main Street: QUAIL\_RUN\_RD Cross Street: DONNIS\_RD Location: SE

ADA ID: RPRK220217185817 Ramp Type: Type 1 - Perpendicular Diagonal Initial Pass/Fail: Pass Overall Compliance: No Severity Score: 20

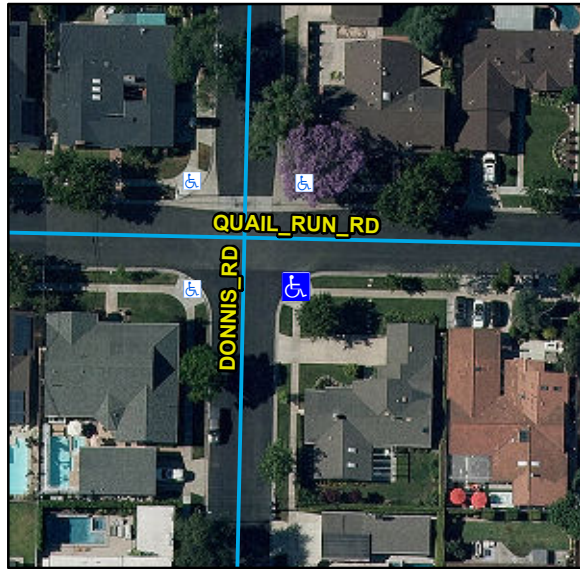
| Compliance | Description | Data | Compliance | Description | Data |
|---|---|---|---|---|---|
| No | Landing Run Slope (%) | 2.8 | N/A | Flare Traversable RT | No |
| Yes | Landing Cross Slope (%) | 2 | No | DWS Provided | No |
| No | Gutter Run Slope (%) | 5.1 | | Road Cross Slope (%) | 4.8 |

**Remove & Replace Curb Ramp With Two New Directional Ramps or Equivalent. Remove & Replace Gutter.**
