# Access Compliance Report Public Rights-of-Way (Curb Ramps)

Main Street: DONNIS\_RD Cross Street: QUAIL\_RUN\_RD Location: SW

ADA ID: RPRK220217190245 Ramp Type: Type 1 - Perpendicular Diagonal Initial Pass/Fail: Pass Overall Compliance: No Severity Score: 18

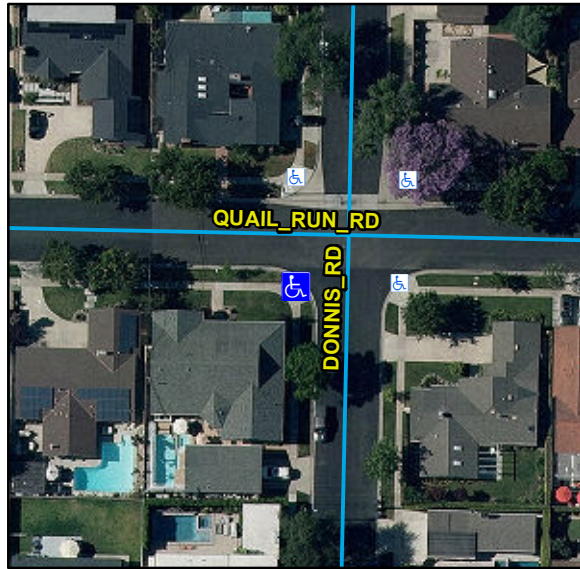
| Compliance | Description | Data | Compliance | Description | Data |
|---|---|---|---|---|---|
| No | Landing Run Slope (%) | 2.4 | N/A | Flare Traversable RT | No |
| Yes | Landing Cross Slope (%) | 0.2 | No | DWS Provided | No |

Remove & Replace Curb Ramp With Two New Directional Ramps or Equivalent.
