# Access Compliance Report Public Rights-of-Way (Curb Ramps)

Main Street: QUAIL\_RUN\_RD Cross Street: DONNIS\_RD Location: NW

ADA ID: RPRK220217190841 Ramp Type: Type 1 - Perpendicular Diagonal Initial Pass/Fail: Fail Overall Compliance: No Severity Score: 16

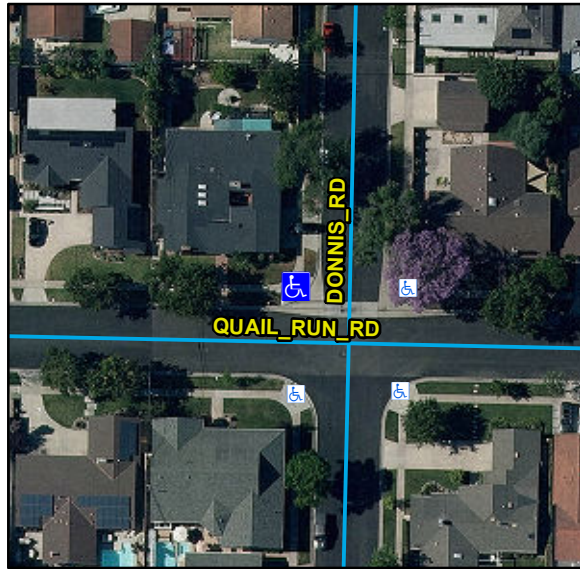
| Compliance | Description | Data | Compliance | Description | Data |
|---|---|---|---|---|---|
| No | Ramp Run Slope (%) | 8.5 | N/A | Flare Slope LT (%) | N/A |

**Remove & Replace Curb Ramp With Two New Directional Ramps or Equivalent.**

**R204.3, R304.2.2, STD 1115**
