# Access Compliance Report Public Rights-of-Way (Curb Ramps)

Main Street: RUTH\_ELAINE\_DR Cross Street: DONNIS\_RD Location: SE

ADA ID: RPRK220217191702 Ramp Type: Type 1 - Perpendicular Diagonal Initial Pass/Fail: Pass Overall Compliance: No Severity Score: 10

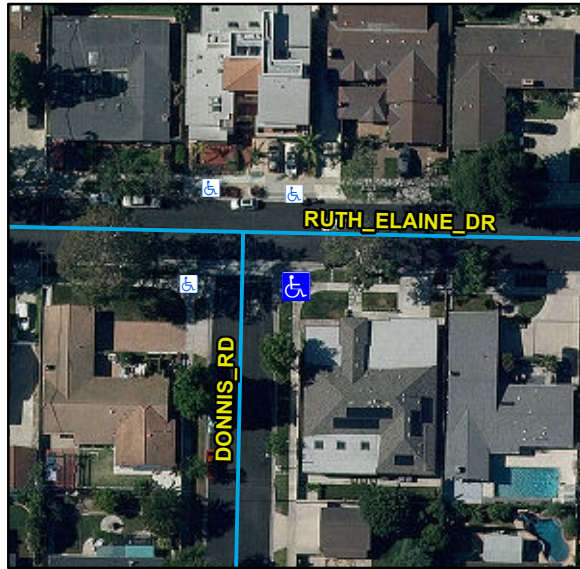
| Compliance | Description | Data | Compliance | Description | Data |
|---|---|---|---|---|---|
| No | Landing Run Slope (%) | 3.6 | N/A | Flare Traversable RT | No |
| Yes | Landing Cross Slope (%) | 0.9 | No | DWS Provided | No |

**Remove & Replace Curb Ramp With Two New Directional Ramps or Equivalent.**
