# Access Compliance Report Public Rights-of-Way (Curb Ramps)

Main Street: RUTH\_ELAINE\_DR Cross Street: WALLINGSFORD\_RD Location: NW

ADA ID: RPRK220217192922 Ramp Type: Type 1 - Perpendicular Diagonal Initial Pass/Fail: Fail Overall Compliance: No Severity Score: 15

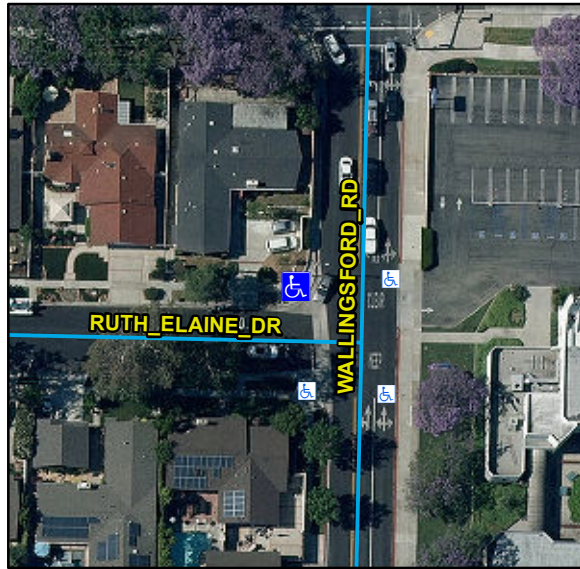
| Compliance | Description | Data | Compliance | Description | Data |
|---|---|---|---|---|---|
| No | Ramp Run Slope (%) | 9.1 | N/A | Flare Slope LT (%) | N/A |

Remove & Replace Curb Ramp With Two New Directional Ramps or Equivalent.
