# Access Compliance Report Public Rights-of-Way (Curb Ramps)

Main Street: WALLINGSFORD\_RD Cross Street: RUTH\_ELAINE\_DR Location: SW

ADA ID: RPRK220217193248 Ramp Type: Type 1 - Perpendicular Diagonal Initial Pass/Fail: Pass Overall Compliance: No Severity Score: 10

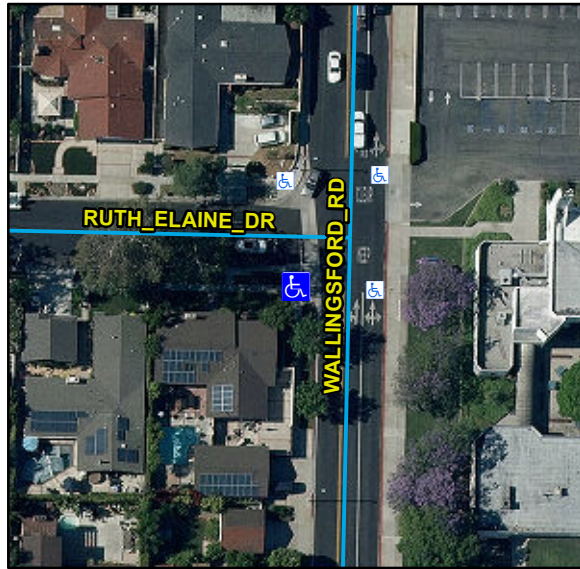
| Compliance | Description | Data | Compliance | Description | Data |
|---|---|---|---|---|---|
| No | Landing Run Slope (%) | 2.4 | N/A | Flare Traversable RT | No |
| Yes | Landing Cross Slope (%) | 0.6 | No | DWS Provided | No |

Remove & Replace Curb Ramp With Two New Directional Ramps or Equivalent.
