# Access Compliance Report Public Rights-of-Way (Curb Ramps)

Main Street: WALLINGSFORD\_RD Cross Street: QUAIL\_RUN\_RD Location: E

ADA ID: RPRK220217193921 Ramp Type: Type 1 - Perpendicular Initial Pass/Fail: Pass Overall Compliance: No Severity Score: 6

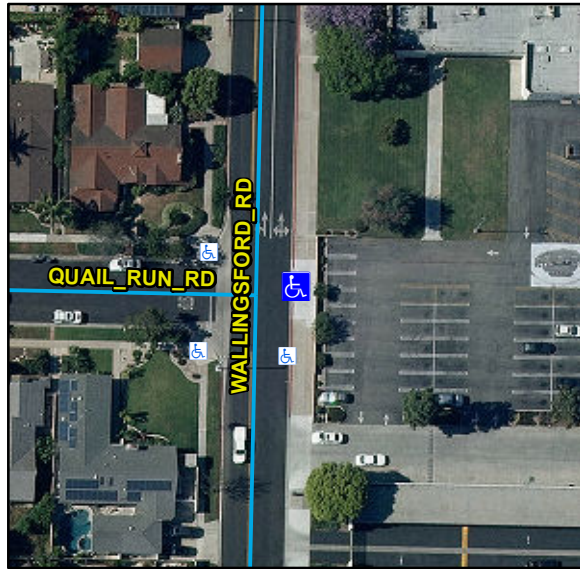
| Compliance | Description | Data | Compliance | Description | Data |
|---|---|---|---|---|---|
| N/A | Landing Movement Obstructed? | Yes | Yes | DWS Contrast | Yes |
| | Landing Movement Type | Wall | Yes | DWS Length (in) | 36 |
| No | Gutter Run Slope (%) | 6.8 | | Road Cross Slope (%) | N/A |

Remove & Replace Landing. Remove & Replace Gutter.

R304.2.1, R304.5.4, STD 1115

Total Cost: \$ 783
