# Access Compliance Report Public Rights-of-Way (Curb Ramps)

Main Street: DONNIS\_RD Cross Street: QUAIL\_RUN\_RD Location: NE

ADA ID: RPRK220217194738 Ramp Type: Type 1 - Perpendicular Diagonal Initial Pass/Fail: Pass Overall Compliance: No Severity Score: 16

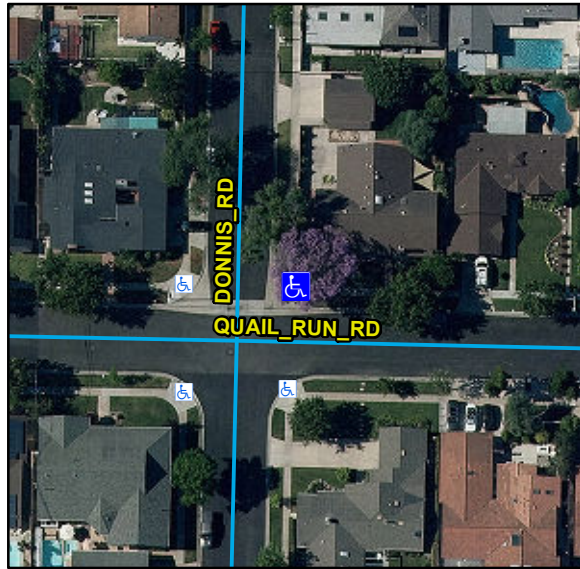
| Compliance | Description | Data | Compliance | Description | Data |
|---|---|---|---|---|---|
| No | Landing Run Slope (%) | 2.2 | N/A | Flare Traversable RT | No |
| Yes | Landing Cross Slope (%) | 0.2 | No | DWS Provided | No |
| No | Gutter Run Slope (%) | 5.4 | | Road Cross Slope (%) | 3 |

Remove & Replace Curb Ramp With Two New Directional Ramps or Equivalent. Remove & Replace Gutter.
