# Access Compliance Report Public Rights-of-Way (Curb Ramps)

Main Street: WALLINGSFORD\_RD Cross Street: QUAIL\_RUN\_RD Location: SW

ADA ID: RPRK220218140743 Ramp Type: Type 1 - Perpendicular Diagonal Initial Pass/Fail: Pass Overall Compliance: No Severity Score: 10

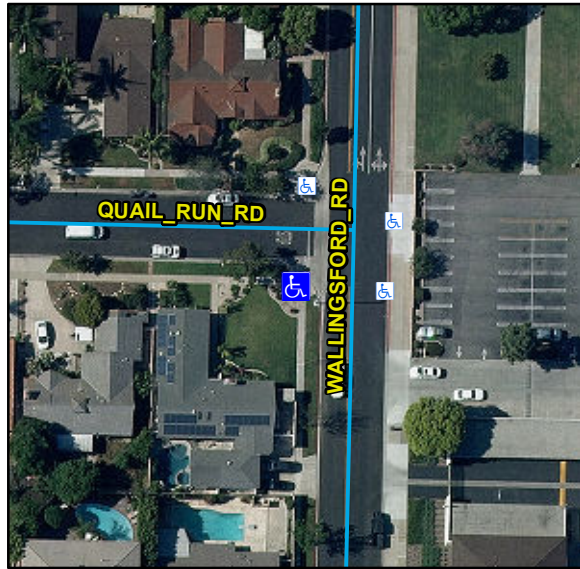
| Compliance | Description | Data | Compliance | Description | Data |
|---|---|---|---|---|---|
| No | Landing Run Slope (%) | 2.3 | N/A | Flare Traversable RT | No |
| Yes | Landing Cross Slope (%) | 0.3 | No | DWS Provided | No |

Remove & Replace Curb Ramp With Two New Directional Ramps or Equivalent.

R304.2.2-Perp, R304.3.2-Para, R305, STD 1115

Total Cost: \$ 6160
