# Access Compliance Report Public Rights-of-Way (Curb Ramps)

Main Street: QUAIL\_RUN\_RD Cross Street: WALLINGSFORD\_RD Location: NW

ADA ID: RPRK220218141251 Ramp Type: Type 1 - Perpendicular Diagonal Initial Pass/Fail: Pass Overall Compliance: No Severity Score: 10

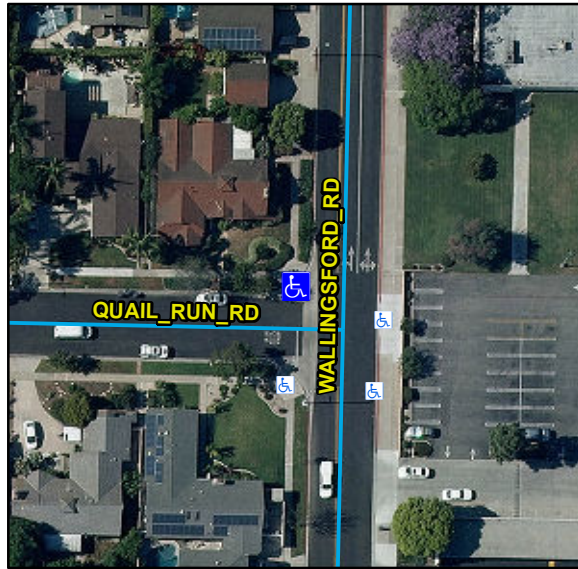
| Compliance | Description | Data | Compliance | Description | Data |
|---|---|---|---|---|---|
| Yes | Landing Cross Slope (%) | 0.1 | No | DWS Provided | No |

Possible Solutions:

Install Detectable Warning System.
