# Access Compliance Report Public Rights-of-Way (Curb Ramps)

Main Street: **DONNIE\_ANN\_RD** Cross Street: **WALLINGSFORD\_RD** Location: **NW**

ADA ID: **RPRK220218141752** Ramp Type: **Type 1 - Perpendicular Diagonal** Initial Pass/Fail: **Fail** Overall Compliance: **No** Severity Score: **0**

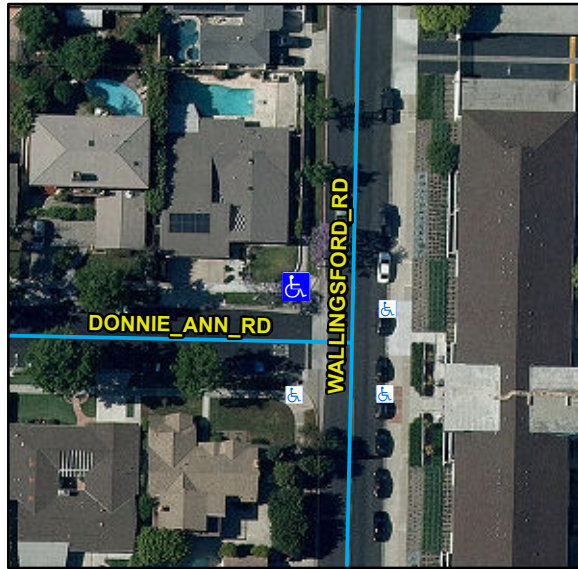
| Compliance | Description | Data | Compliance | Description | Data |
|---|---|---|---|---|---|
| N/A | Ramp Length (in) | 84 | N/A | Flare Type LT | |
| Yes | Ramp Width (in) | 48 | | | Sloped |
| Yes | Ramp Run Slope (%) | 7 | N/A | Flare Slope LT (%) | N/A |
| Yes | Ramp Cross Slope (%) | 1.1 | N/A | Flare Traversable LT | No |
| N/A | Landing Cross Slope (%) | 1.7 | N/A | DWS Provided | No |

**Remove & Replace Curb Ramp With Two New Directional Ramps or Equivalent.**

**R204.3, STD 1115**

Total Cost: \$ **6160**
