# Access Compliance Report Public Rights-of-Way (Curb Ramps)

| Main Street: WALLINGSFORD_RD | | Cross Street: DONNIE_ANN_RD | | Location: | SW |
| ADA ID: RPRK220218142051 | Ramp Type:Type 1 - Perpendicular Diagonal Initial Pass/Fail: Pass | | Overall Compliance: No | Severity Score: | 10 |

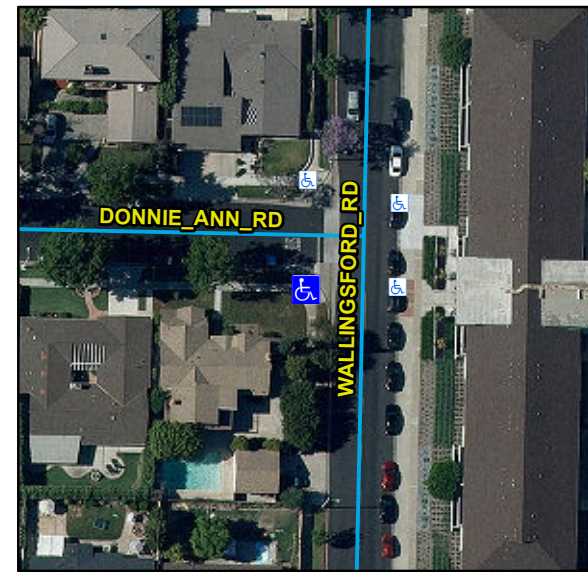
| Compliance | Description | Data | Compliance | Description | Data |
|---|---|---|---|---|---|
| No | Landing Run Slope (%) | 2.3 | N/A | Flare Traversable RT | Yes |
| Yes | Landing Cross Slope (%) | 0.7 | No | DWS Provided | No |

**Remove & Replace Curb Ramp With Two New Directional Ramps or Equivalent.**

**R304.2.2-Perp, R304.3.2-Para, R305, STD 1115**

Total Cost: \$ 6160
