# Access Compliance Report Public Rights-of-Way (Curb Ramps)

| Main Street: CHIANTI_DR | | Cross Street: CHIANTI_DR | | Location: | E |
| ADA ID: RPRK220218145055 | Ramp Type:Type 1 - Perpendicular | Initial Pass/Fail: Pass | Overall Compliance: No | Severity Score: | 19 |

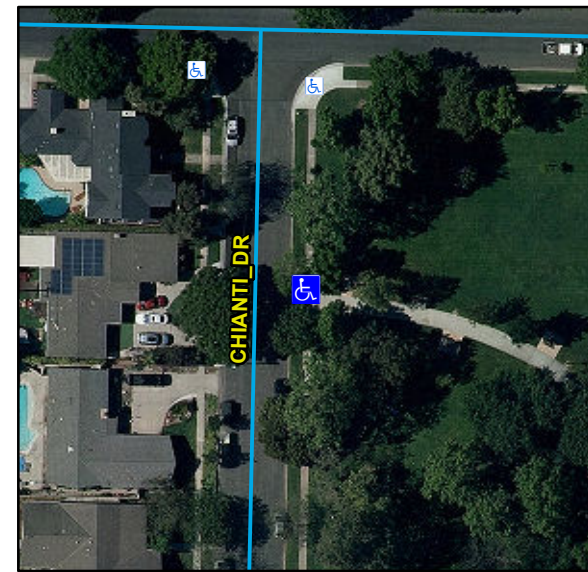
| Compliance | Description | Data | Compliance | Description | Data |
|---|---|---|---|---|---|
| No | Landing Run Slope (%) | 3.1 | N/A | Flare Traversable RT | No |
| Yes | Landing Cross Slope (%) | 0.9 | No | DWS Provided | No |
| No | Gutter Lip Height (in) | 0.5 | | Road Run Slope (%) | N/A |
| No | Gutter Run Slope (%) | 7.1 | | Road Cross Slope (%) | N/A |

**Remove & Replace Entire Ramp. Remove & Replace Gutter.**

**R304.2.2-Perp, R304.3.2-Para, R305, R302.7.2, R304.5.4, STD 1115**

Total Cost: \$ 3332

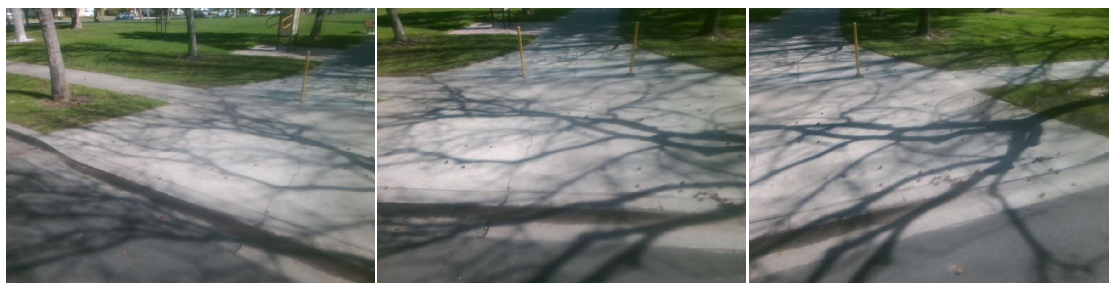
| Compliance | Description | Data | Compliance | Description | Data |
|---|---|---|---|---|---|
| N/A | Ramp Length (in) | 131 | N/A | Flare Type LT | |
| Yes | Ramp Width (in) | 235 | | | Sloped |
| Yes | Ramp Run Slope (%) | 6.2 | N/A | Flare Slope LT (%) | N/A |
