# Access Compliance Report Public Rights-of-Way (Curb Ramps)

| Main Street: CHIANTI_DR | | Cross Street: CHIANTI_DR | | Location: | E |
| ADA ID: RPRK220218145651 | Ramp Type:Type 1 - Perpendicular | Initial Pass/Fail: Pass | Overall Compliance: No | Severity Score: | 20 |

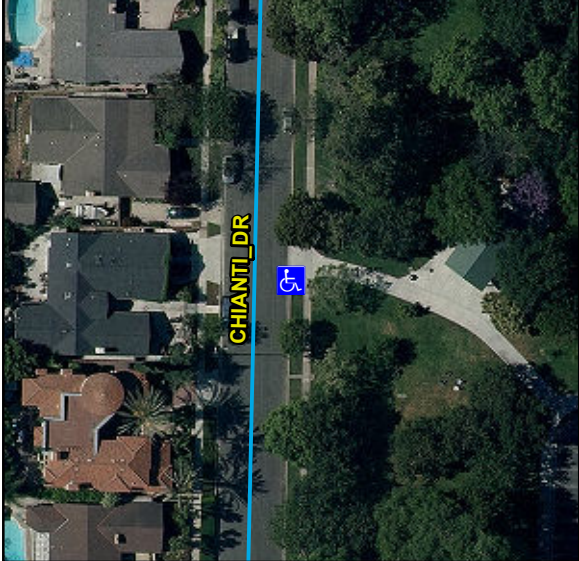
| | | | No | Landing Run Slope (%) | 4.3 | N/A | Flare Traversable RT | No |
| | | | Yes | Landing Cross Slope (%) | 0.9 | No | DWS Provided | No |

| | Remove & Replace Entire Ramp. Remove & Replace Gutter. | | N/A | Ramp Length (in) | 84 | N/A | Flare Type LT | |
| | Total Cost: | | \$ | 3332 | | N/A | Marked Crosswalk 1 | No |
