# Access Compliance Report Public Rights-of-Way (Curb Ramps)

Main Street: BROOKHURST\_ST Cross Street: ORANGE\_AVE Location: NE

ADA ID: RPRK220218194249 Ramp Type: Type 4 - Parallel Initial Pass/Fail: Pass Overall Compliance: No Severity Score: 5

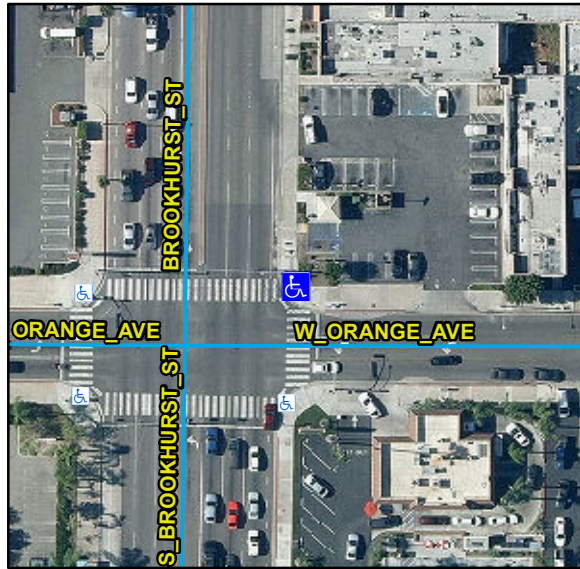
| Compliance | Description | Data | Compliance | Description | Data |
|---|---|---|---|---|---|
| No | Gutter Run Slope (%) | 7.1 | | Road Cross Slope (%) | 2 |

Remove & Replace Gutter. Utility Present.

R304.5.4, STD 1115
