# Access Compliance Report Public Rights-of-Way (Curb Ramps)

Main Street: **ORANGE\_AVE** Cross Street: **S\_GREENWICH\_ST** Location: **NE**

ADA ID: **RPRK220218201818** Ramp Type: **Type 4 - Parallel** Initial Pass/Fail: **Pass** Overall Compliance: **No** Severity Score: **0**

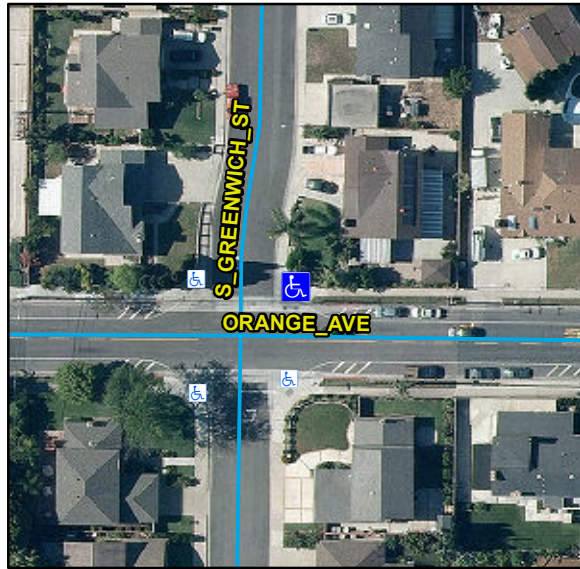
**Gutter Ponding Observed.**

| Compliance | Description | Data | Compliance | Description | Data |
|---|---|---|---|---|---|
| <b>No</b> | Gutter Ponding | <b>Yes</b> | <b>Yes</b> | Curb Slope | <b>0.5</b> |

**R302.7, STD 1115**

Total Cost: \$ **252**
