# Access Compliance Report Public Rights-of-Way (Curb Ramps)

Main Street: ORANGE\_AVE Cross Street: S\_GREENWICH\_ST Location: SE

ADA ID: RPRK220218202332 Ramp Type: Type 4 - Parallel Initial Pass/Fail: Fail Overall Compliance: No Severity Score: 2

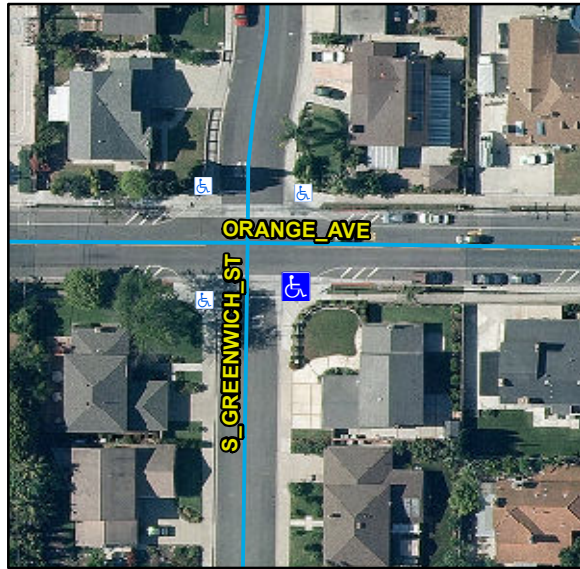
| Compliance | Description | Data | Compliance | Description | Data |
|---|---|---|---|---|---|
| No | Ramp Cross Slope LT (%) | 2.1 | Yes | Ramp Cross Slope RT (%) | 0.6 |

**Remove & Replace Curb Ramp With Two New Directional Ramps or Equivalent.**

**R304.5.3, STD 1115**
