# Access Compliance Report Public Rights-of-Way (Curb Ramps)

Main Street: ORANGE\_AVE Cross Street: ORANGE\_AVE Location: N

ADA ID: RPRK220218203654 Ramp Type: Type 1 - Perpendicular Initial Pass/Fail: Fail Overall Compliance: No Severity Score: 0

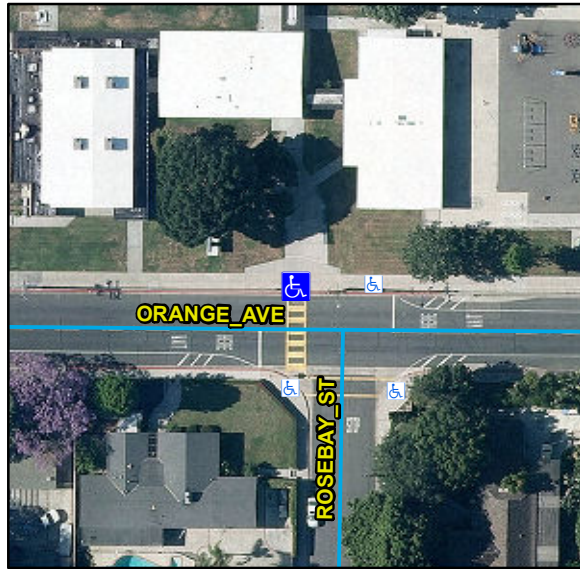
| Compliance | Description | Data | Compliance | Description | Data |
|---|---|---|---|---|---|
| N/A | Ramp Length (in) | 127 | N/A | Flare Type LT | |
| Yes | Ramp Width (in) | 48 | | | Sloped |
| Yes | Ramp Run Slope (%) | 6.6 | N/A | Flare Slope LT (%) | 4.6 |
| Yes | Ramp Cross Slope (%) | 0.5 | N/A | Flare Traversable LT | Yes |
| N/A | Landing Width (in) | 62 | N/A | Flare Slope RT (%) | 7.1 |
| N/A | Gutter Run Slope (%) | 6.5 | | Road Cross Slope (%) | N/A |

**Remove & Replace Entire Ramp.**

**STD 1115**
