# Access Compliance Report Public Rights-of-Way (Curb Ramps)

Main Street: BROADWAY Cross Street: THISTLE\_RD Location: SE

ADA ID: RPRK220218205215 Ramp Type: Type 4 - Parallel Initial Pass/Fail: Fail Overall Compliance: No Severity Score: 2

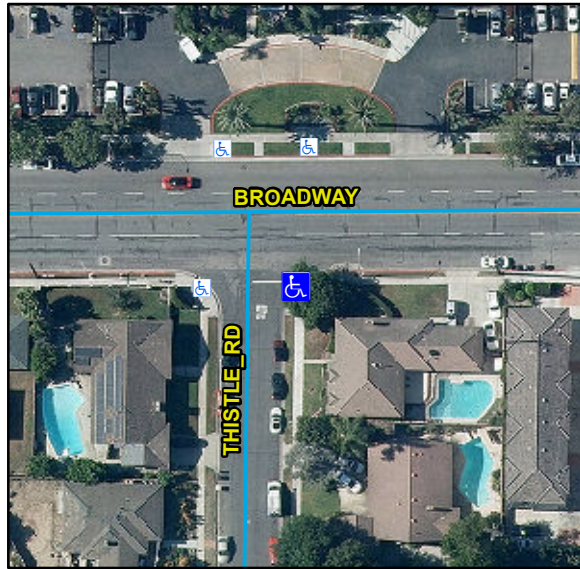
| Compliance | Description | Data | Compliance | Description | Data |
|---|---|---|---|---|---|
| No | Ramp Cross Slope LT (%) | 2.3 | Yes | Ramp Cross Slope RT (%) | 0.4 |

**Remove & Replace Curb Ramp With Two New Directional Ramps or Equivalent.**

**R304.5.3, STD 1115**

Total Cost: \$ 4000
