# Access Compliance Report Public Rights-of-Way (Curb Ramps)

Main Street: BROADWAY Cross Street: GREENWICH\_LN\_001 Location: SE

ADA ID: RPRK220218210345 Ramp Type: Type 4 - Parallel Initial Pass/Fail: Fail Overall Compliance: No Severity Score: 2

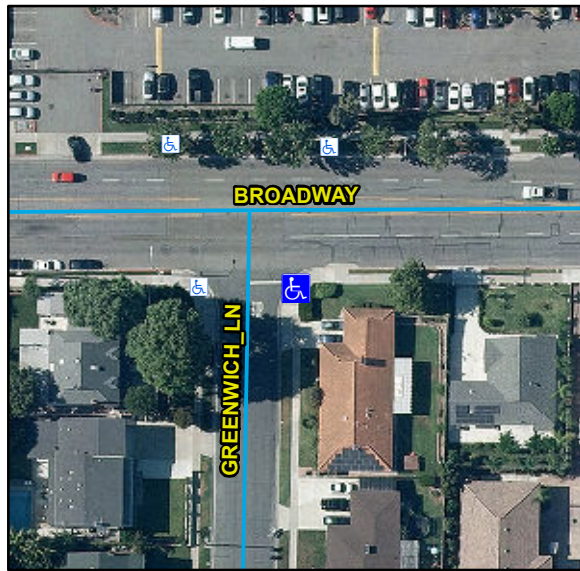
| Compliance | Description | Data | Compliance | Description | Data |
|---|---|---|---|---|---|
| No | Ramp Cross Slope LT (%) | 4.4 | No | Ramp Cross Slope RT (%) | 2.1 |

Remove & Replace Curb Ramp With Two New Directional Ramps or Equivalent.

R304.5.3, STD 1115
