# Access Compliance Report Public Rights-of-Way (Curb Ramps)

Main Street: GREENWICH\_LN Cross Street: BROADWAY Location: SW

ADA ID: RPRK220218210714 Ramp Type: Type 3 - Combination 1 Initial Pass/Fail: Fail Overall Compliance: No Severity Score: 5

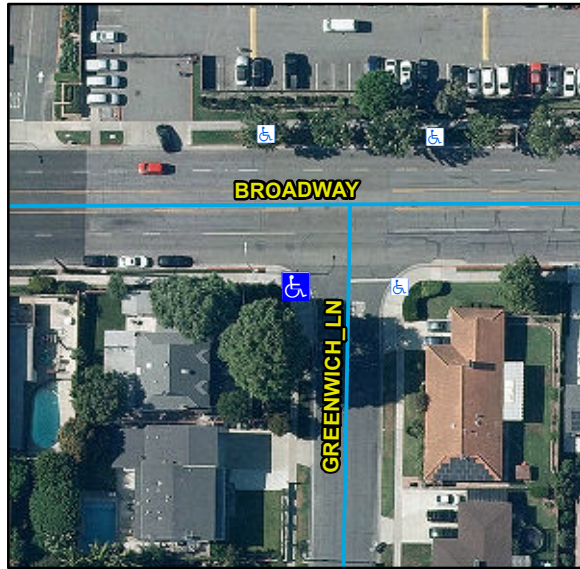
| Compliance | Description | Data | Compliance | Description | Data |
|---|---|---|---|---|---|
| Yes | Ramp Width LT (in) | 59 | No | Ramp Width RT (in) | 45 |
| No | Ramp Cross Slope LT (%) | 3.7 | No | Ramp Cross Slope RT (%) | 4.4 |

Remove & Replace Curb Ramp With Two New Directional Ramps or Equivalent. Remove & Replace Sidewalk.

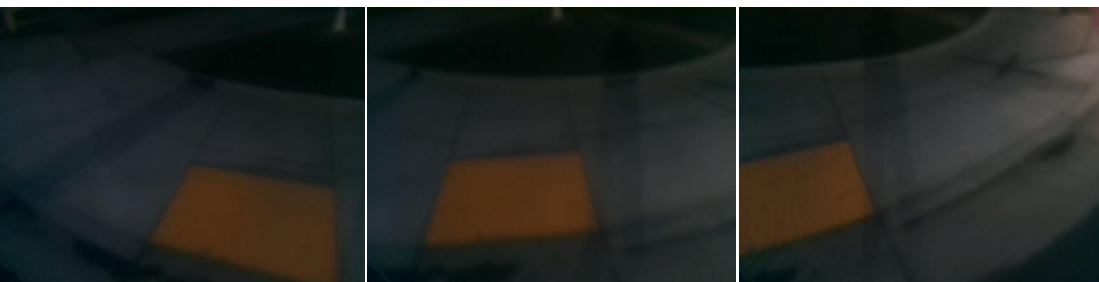
| Compliance | Description | Data | Compliance | Description | Data |
|---|---|---|---|---|---|
| N/A | Ramp Length LT (in) | 80 | N/A | Ramp Length RT (in) | 82 |
| Yes | Ramp Run Slope LT (%) | 8 | Yes | Ramp Run Slope RT (%) | 4 |
