# Access Compliance Report Public Rights-of-Way (Curb Ramps)

Main Street: N/A Cross Street: CERRITOS\_AVE Location: N

ADA ID: RPRK220221120517 Ramp Type: Type 6 - Directional 1 Initial Pass/Fail: Pass Overall Compliance: No Severity Score: 2

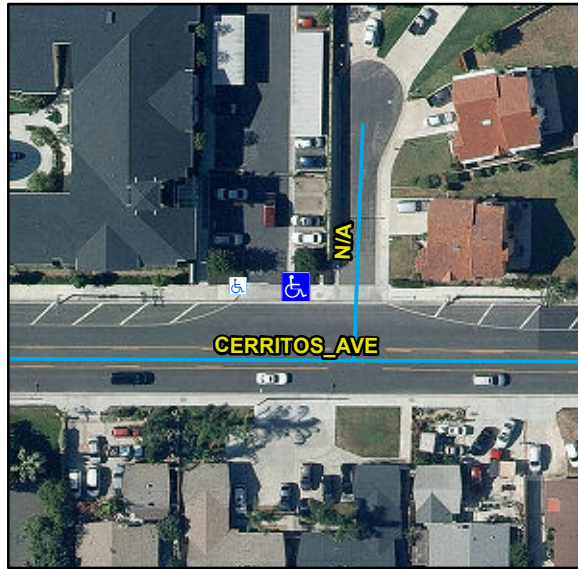
| Compliance | Description | Data | Compliance | Description | Data |
|---|---|---|---|---|---|
| Yes | Grade Break | Yes | No | Flare Type RT | |
| Yes | Grade Break Slope (%) | 2.7 | | | Curbed1 |

Possible Solutions:

Remove & Replace Curbed Edge.

R304.2.3, STD 1115

\$ 500
