## **Access Compliance Report Public Rights-of-Way** (Curb Ramps)

Main Street: N/A **Cross Street: CERRITOS AVE** Location: NW

ADA ID: RPRK220221121127 Ramp Type: Type 6 - Directional 1 **Initial Pass/Fail: Pass Overall Compliance: No Severity Score:** 2

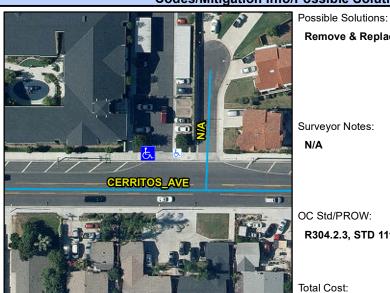
Field Measurements/Component Compliance									
Ī	Compliance Description		Data	Compliance Description		Data			
	N/A	Ramp Length (in)	80	No	Flare Type LT				
	Yes	Ramp Width (in)	48			Curbed1			
	Yes	Ramp Run Slope (%)	3.8	N/A	Flare Slope LT (%)	N/A			
	Yes	Ramp Cross Slope (%)	1.6	N/A	Flare Traversable LT	N/A			
	Yes	Grade Break	Yes	Yes	Flare Type RT				
	Yes	Grade Break Slope (%)	2			Curbed2			
	Yes	Grade Break Cross Slope (%)	1.6	N/A	Flare Slope RT (%)	N/A			
		Addl Para Ramp Left?	No	N/A	Flare Traversable RT	N/A			
		Addl Para Ramp Right?	No	Yes	DWS Provided	Yes			
	N/A	Landing Present	Yes	Yes	DWS Contrast	Yes			
	Yes	Landing Length (in)	63	Yes	DWS Length (in)	36			
	Yes	Landing Width (in)	90	Yes	DWS Full Width	Yes			
	Yes	Landing Run Slope (%)	0.7		DWS Offset Type	Multiple			
	Yes	Landing Cross Slope (%)	0.6	Yes	DWS Left Offset (in)	0			
00	N/A	Landing Movement Obstructed?	No	Yes	DWS Right Offset (in)	12

Remove & Replace Curbed Edge.

R304.2.3, STD 1115
