# Access Compliance Report

## Public Rights-of-Way

### (Curb Ramps)

Main Street: BROOKHURST\_ST Cross Street: BROADWAY Location: SE

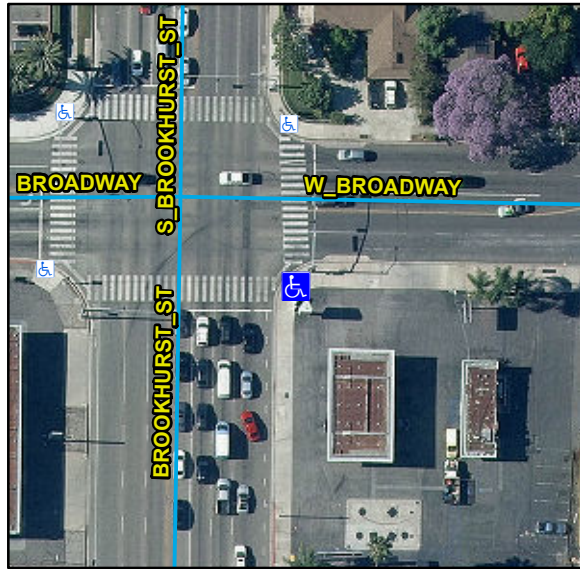
ADA ID: RPRK220221125930 Ramp Type: Type 1 - Perpendicular Diagonal Initial Pass/Fail: Fail Overall Compliance: No Severity Score: 0

Surveyor Notes:

N/A

Possible Solutions:

**Remove & Replace Curb Ramp With Two New Directional Ramps or Equivalent.**

OC Std/PROW:

STD 1115

Total Cost: \$ 6160
