# Access Compliance Report Public Rights-of-Way (Curb Ramps)

Main Street: BROADWAY Cross Street: BROOKHURST\_ST Location: NW

ADA ID: RPRK220221131354 Ramp Type: Type 1 - Perpendicular Diagonal Initial Pass/Fail: Fail Overall Compliance: No Severity Score: 0

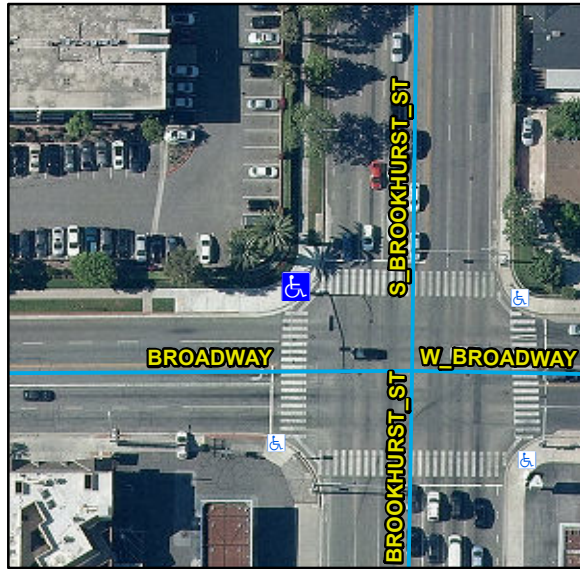
| Compliance | Description | Data | Compliance | Description | Data |
|---|---|---|---|---|---|
| N/A | Ramp Length (in) | 80 | N/A | Flare Type LT | |
| Yes | Ramp Width (in) | 48 | | | Sloped |
| Yes | Ramp Run Slope (%) | 3.7 | N/A | Flare Slope LT (%) | 7.8 |
| Yes | Ramp Cross Slope (%) | 0.5 | N/A | Flare Traversable LT | No |
| N/A | Ramp Inside Crosswalk 1 | Yes | Yes | Ramp Inside Crosswalk 2 | Yes |

Remove & Replace Curb Ramp With Two New Directional Ramps or Equivalent.

STD 1115

Total Cost: \$ 6160
