# Access Compliance Report

## Public Rights-of-Way

### (Curb Ramps)

Main Street: BROOKHURST\_ST Cross Street: BROADWAY Location: NE

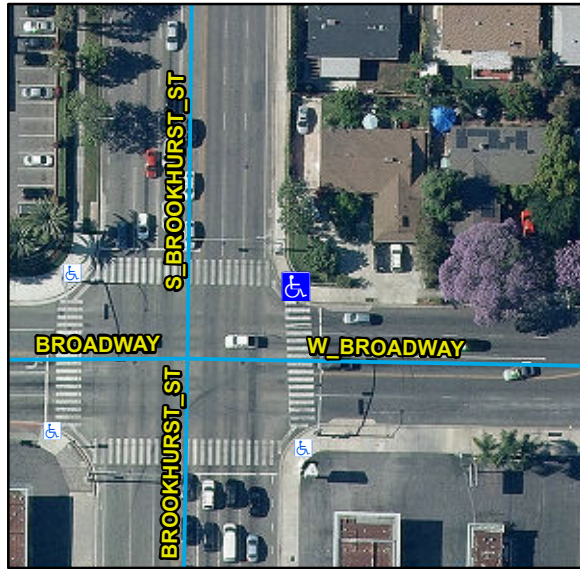
ADA ID: RPRK220221132038 Ramp Type: Type 1 - Perpendicular Diagonal Initial Pass/Fail: Pass Overall Compliance: No Severity Score: 24

**Remove & Replace Curb Ramp With Two New Directional Ramps or Equivalent. Grind Gutter Lip. Utility Present.**
