# Access Compliance Report Public Rights-of-Way (Curb Ramps)

Main Street: STREET\_OF\_THE\_GOLDEN\_LANTERN Cross Street: DANA\_POINT\_HARBOR\_DR Location: SW

ADA ID: RPRK220221150540 Ramp Type: Type 1 - Perpendicular Diagonal Initial Pass/Fail: Pass Overall Compliance: No Severity Score: 26

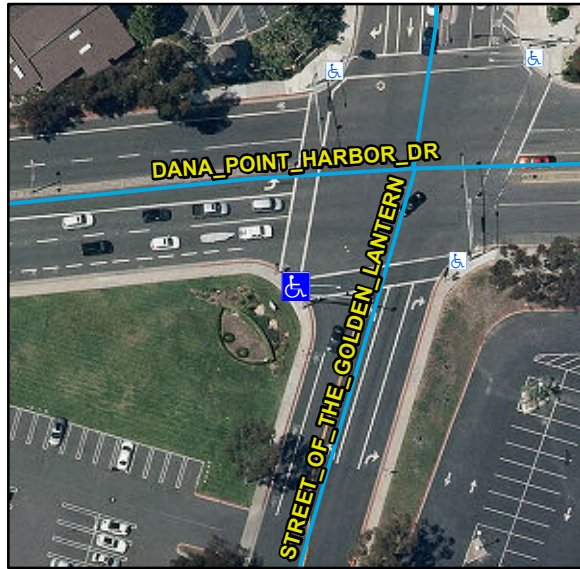
| Compliance | Description | Data | Compliance | Description | Data |
|---|---|---|---|---|---|
| No | Landing Cross Slope (%) | N/A | No | DWS Provided | No |
| No | Gutter Run Slope (%) | 7.2 | | Road Cross Slope (%) | 2.7 |

Remove & Replace Curb Ramp With Two New Directional Ramps or Equivalent. Remove & Replace Gutter.
