# Access Compliance Report Public Rights-of-Way (Curb Ramps)

Main Street: DANA\_POINT\_HARBOR\_DR Cross Street: STREET\_OF\_THE\_GOLDEN\_LANTERN Location: NW

ADA ID: RPRK220221150923 Ramp Type: Type 1 - Perpendicular Diagonal Initial Pass/Fail: Pass Overall Compliance: Yes Severity Score: 0

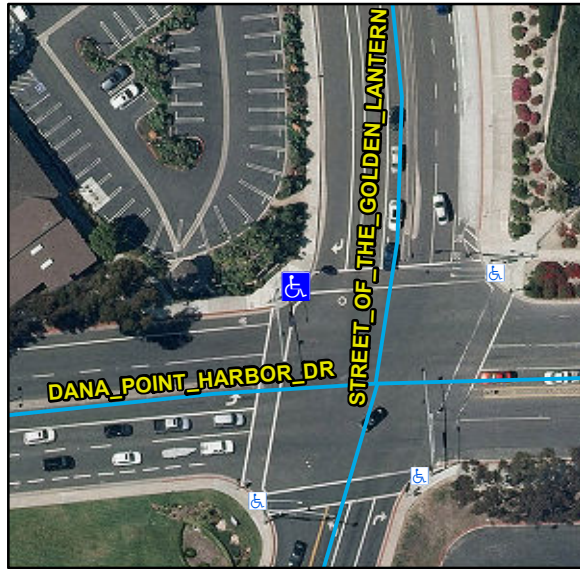
| Compliance | Description | Data | Compliance | Description | Data |
|---|---|---|---|---|---|
| N/A | Ramp Length (in) | 120 | N/A | Flare Type LT | |
| Yes | Ramp Width (in) | 48 | | | Sloped |
| Yes | Ramp Run Slope (%) | 4.4 | N/A | Flare Slope LT (%) | N/A |
| Yes | Ramp Cross Slope (%) | 0.3 | N/A | Flare Traversable LT | No |
| Yes | Overall Surface Condition: Acceptable | | Yes | Perp Joint Present | Yes |

Possible Solutions:

N/A
