Access Compliance Report Public Rights-of-Way (Curb Ramps)

Main Street: STREET_OF_THE_GOLDEN_LANTERN Cross Street: STREET_OF_THE_GOLDEN_LANTERN Location: E

ADA ID: RPRK220221152327 Ramp Type: Type 1 - Perpendicular Initial Pass/Fail: Fail Overall Compliance: No Severity Score: 2

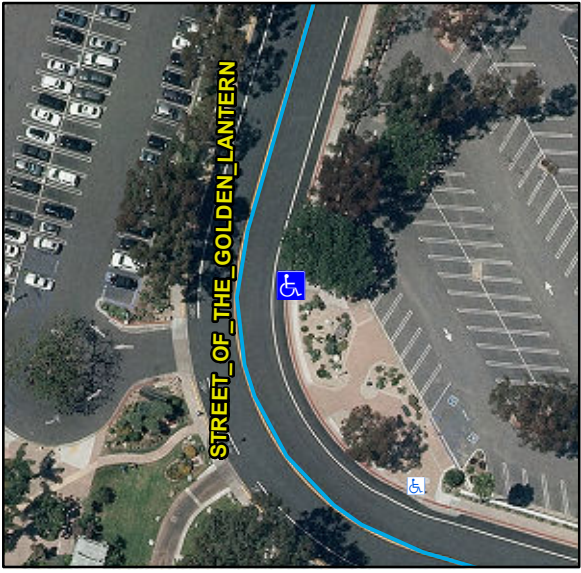
| Compliance | Description | Data | Compliance | Description | Data |
|---|---|---|---|---|---|
| No | Ramp Cross Slope (%) | 2.4 | N/A | Flare Traversable LT | N/A |

Possible Solutions:
Remove & Replace Entire Ramp.

OC Std/PROW:
R304.5.3, STD 1115
