# Access Compliance Report Public Rights-of-Way (Curb Ramps)

Main Street: STREET\_OF\_THE\_GOLDEN\_LANTERN Cross Street: STREET\_OF\_THE\_GOLDEN\_LANTERN Location: SW

ADA ID: RPRK220221152635 Ramp Type:Type 1 - Perpendicular Initial Pass/Fail: Pass Overall Compliance: No Severity Score: 16

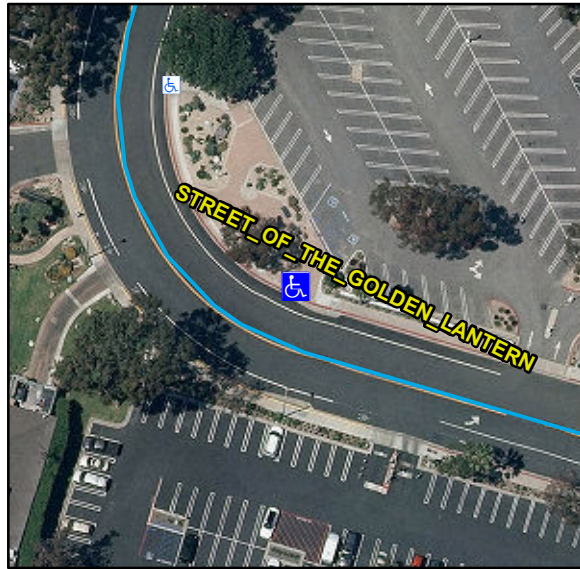
| Compliance | Description | Data | Compliance | Description | Data |
|---|---|---|---|---|---|
| No | Landing Run Slope (%) | 3.8 | N/A | Flare Traversable RT | No |
| Yes | Landing Cross Slope (%) | 0.6 | No | DWS Provided | No |
| No | Gutter Run Slope (%) | 7.7 | | Road Cross Slope (%) | N/A |

Remove & Replace Entire Ramp. Remove & Replace Gutter.
