# Access Compliance Report Public Rights-of-Way (Curb Ramps)

| Main Street: DANA_POINT_HARBOR_DR | | Cross Street: CASITAS_PL | | Location: | N |
| ADA ID: RPRK220221153857 | Ramp Type: Type 4 - Parallel | Initial Pass/Fail: Pass | Overall Compliance: Yes | Severity Score: | 0 |

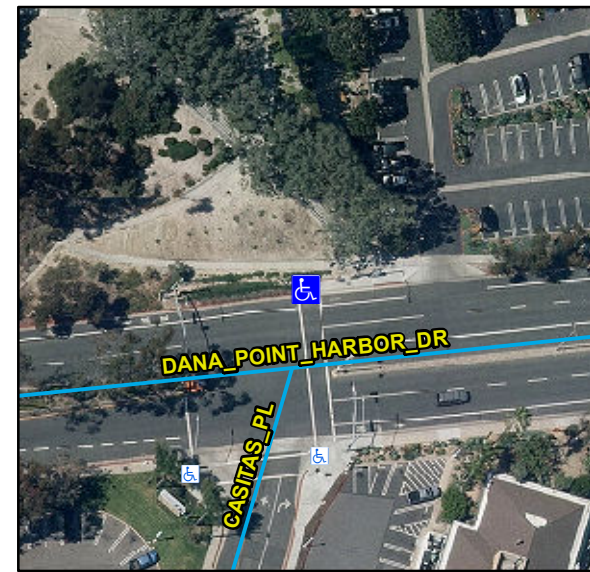
Surveyor Notes:

N/A

Possible Solutions:

N/A

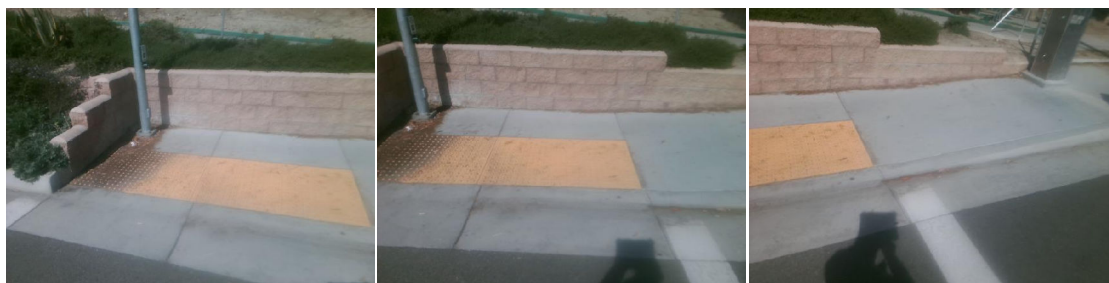
| Compliance | Description | Data | Compliance | Description | Data |
|---|---|---|---|---|---|
| N/A | Ramp Length LT (in) | -9999 | N/A | Ramp Length RT (in) | 125 |
| N/A | Ramp Width LT (in) | -9999 | Yes | Ramp Width RT (in) | 72 |
| N/A | Ramp Run Slope LT (%) | -9999 | Yes | Ramp Run Slope RT (%) | 3.2 |
| N/A | Ramp Cross Slope LT (%) | -9999 | Yes | Ramp Cross Slope RT (%) | 1.2 |
| N/A | Landing Present | Yes | Yes | DWS Provided | Yes |
| N/A | Landing Length (in) | 60 | Yes | DWS Contrast | Yes |
| Yes | Landing Width (in) | 117 | Yes | DWS Length (in) | 36 |
| Yes | Landing Run Slope (%) | 1.4 | Yes | DWS Full Width | Yes |
| Yes | Landing Cross Slope (%) | 1.4 | | DWS Offset Type | Single |
