# Access Compliance Report Public Rights-of-Way (Curb Ramps)

Main Street: DANA\_DR Cross Street: ISLAND\_WAY Location: N

ADA ID: RPRK220221161230 Ramp Type: Type 1 - Perpendicular Diagonal Initial Pass/Fail: Pass Overall Compliance: No Severity Score: 19

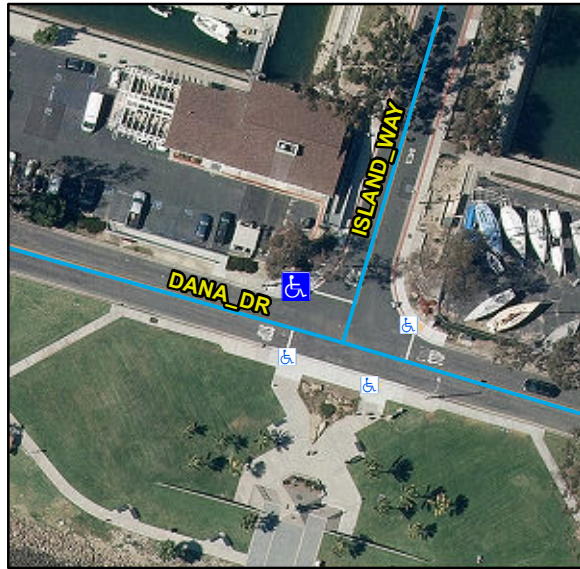
| Compliance | Description | Data | Compliance | Description | Data |
|---|---|---|---|---|---|
| No | Ramp Width (in) | 47 | | | Sloped |
| No | Landing Width (in) | N/A | Yes | Flare Slope RT (%) | 3.4 |
| No | Gutter Run Slope (%) | 6.2 | | Road Cross Slope (%) | 0.3 |

Remove & Replace Curb Ramp With Two New Directional Ramps or Equivalent. Remove & Replace Gutter.
