# Access Compliance Report Public Rights-of-Way (Curb Ramps)

| Main Street: ISLAND_WAY | Cross Street: ISLAND_WAY | Location: W |

| ADA ID: RPRK220221172234 | Ramp Type: Type 4 - Parallel | Initial Pass/Fail: Pass | Overall Compliance: No | Severity Score: 5 |

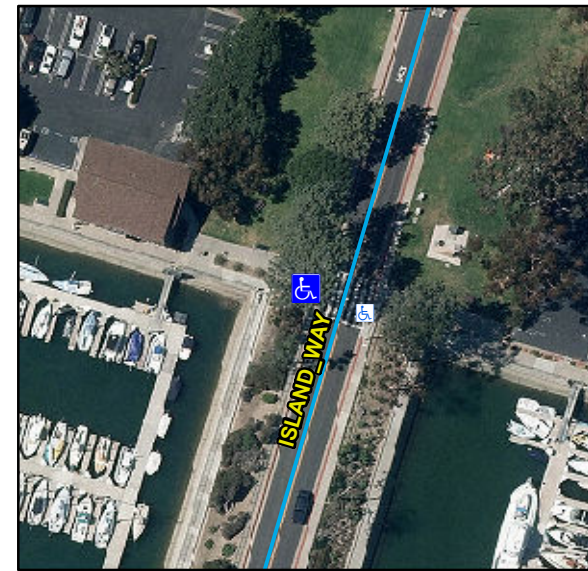
R304.5.4, STD 1115

| Compliance | Description | Data | Compliance | Description | Data |
|---|---|---|---|---|---|
| No | Gutter Run Slope (%) | 5.5 | | Road Cross Slope (%) | N/A |

Possible Solutions:

Remove & Replace Gutter.

Total Cost: \$ 252
