# Access Compliance Report Public Rights-of-Way (Curb Ramps)

Main Street: STREET\_OF\_THE\_GREEN\_LANTERN Cross Street: COVE\_ST Location: SE

ADA ID: RPRK220221174332 Ramp Type:Type 1 - Perpendicular Initial Pass/Fail: Pass Overall Compliance: No Severity Score: 0

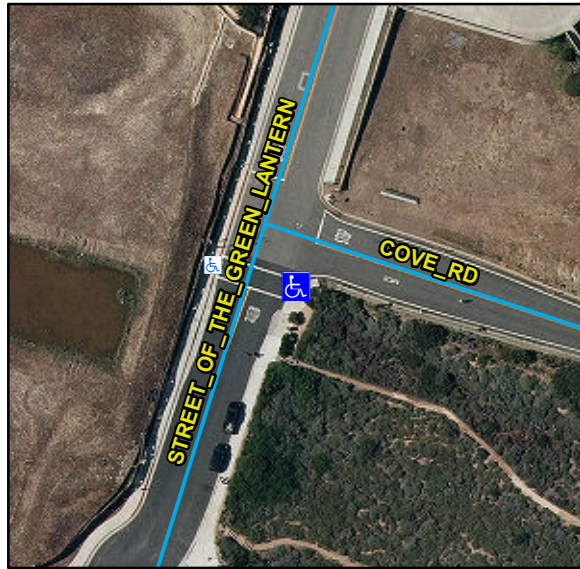
| Compliance | Description | Data | Compliance | Description | Data |
|---|---|---|---|---|---|
| No | Landing Cross Slope (%) | 2.3 | Yes | DWS Provided | Yes |

Possible Solutions:

Remove & Replace Landing.

R304.2.1, R304.5.3, STD 1115
