# Access Compliance Report Public Rights-of-Way (Curb Ramps)

Main Street: STREET\_OF\_THE\_GREEN\_LANTERN Cross Street: SCENIC\_DR Location: S

ADA ID: RPRK220221174823 Ramp Type:Type 1 - Perpendicular Initial Pass/Fail: Pass Overall Compliance: Yes Severity Score: 0

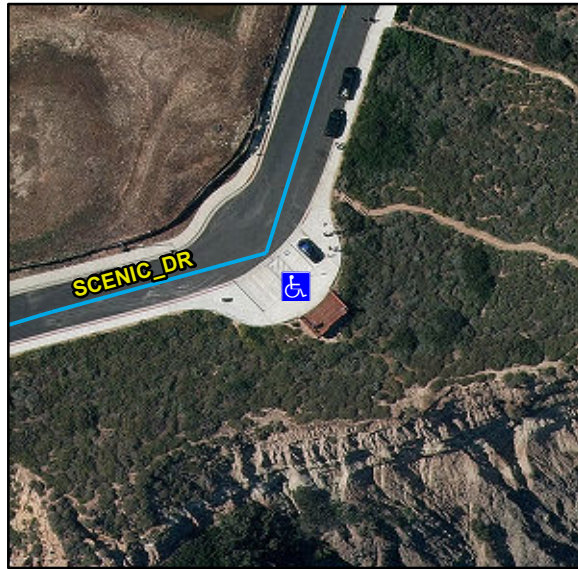
| Compliance | Description | Data | Compliance | Description | Data |
|---|---|---|---|---|---|
| Yes | Overall Surface Condition: Acceptable | | Yes | Perp Joint Present | Yes |

Possible Solutions:

N/A
