# Access Compliance Report Public Rights-of-Way (Curb Ramps)

| Main Street: PEMBERTON_RD | | Cross Street: PEMBERTON_RD | | Location: | SE |
| ADA ID: RPRK220221193614 | Ramp Type: Type 4 - Parallel | Initial Pass/Fail: Fail | Overall Compliance: No | Severity Score: | 2 |

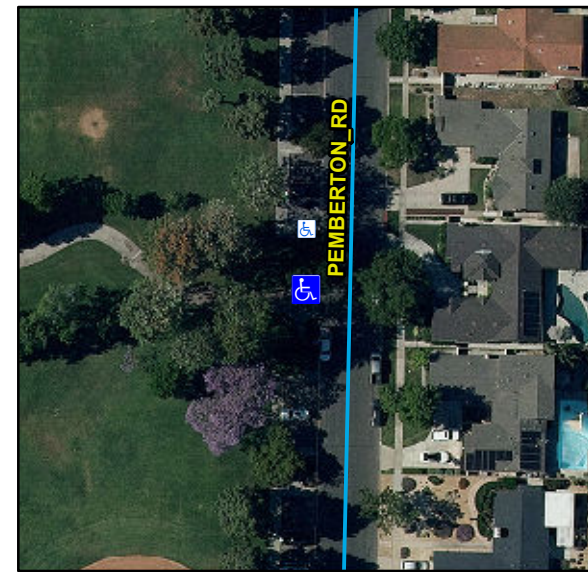
R304.5.3, STD 1115

Possible Solutions:

Remove & Replace Entire Ramp.

Total Cost: \$ 2000

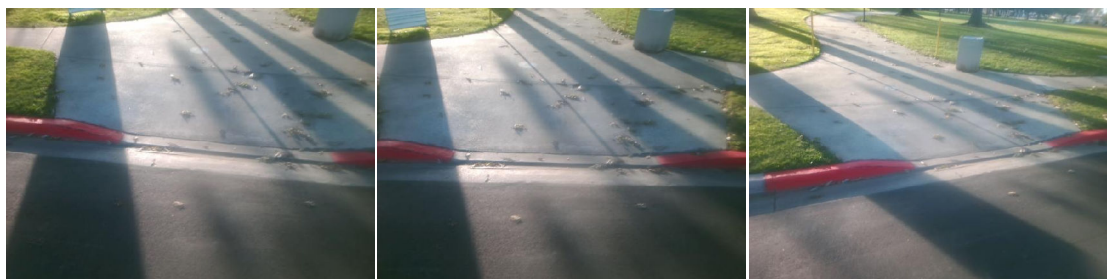
| Compliance | Description | Data | Compliance | Description | Data |
|---|---|---|---|---|---|
| N/A | Ramp Length LT (in) | 84 | N/A | Ramp Length RT (in) | 95 |
| Yes | Ramp Width LT (in) | 77 | Yes | Ramp Width RT (in) | 77 |
| Yes | Ramp Run Slope LT (%) | 3 | Yes | Ramp Run Slope RT (%) | 4.1 |
| No | Ramp Cross Slope LT (%) | 3.5 | No | Ramp Cross Slope RT (%) | 2.4 |
