# Access Compliance Report Public Rights-of-Way (Curb Ramps)

Main Street: KERTH\_DR Cross Street: KERTH\_DR Location: SE

ADA ID: RPRK220221195126 Ramp Type: Type 1 - Perpendicular Initial Pass/Fail: Pass Overall Compliance: No Severity Score: 15

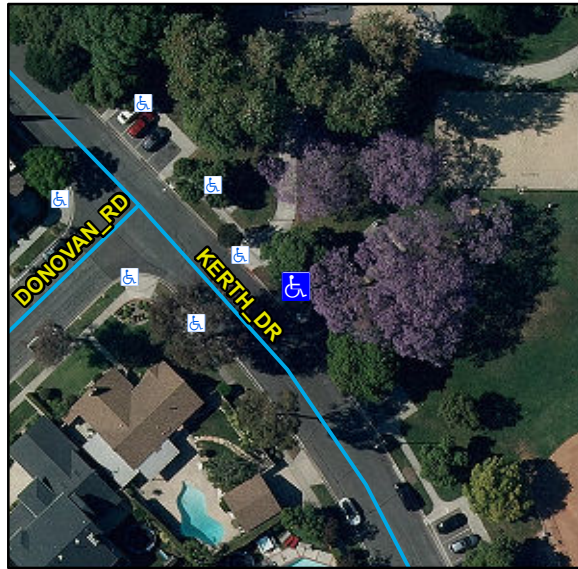
| Compliance | Description | Data | Compliance | Description | Data |
|---|---|---|---|---|---|
| Yes | Ramp Run Slope (%) | 2.7 | No | Flare Slope LT (%) | 10.5 |
| Yes | Landing Width (in) | 48 | No | Flare Slope RT (%) | 20.2 |
| Yes | Landing Cross Slope (%) | 1.1 | No | DWS Provided | No |

Remove & Replace Entire Ramp.

R304.2.3, R305, STD 1115
