# Access Compliance Report Public Rights-of-Way (Curb Ramps)

Main Street: EDINGER\_AVE Cross Street: HARBOR\_BLV Location: SW

ADA ID: RPRK220222150840 Ramp Type: Type 1 - Perpendicular Diagonal Initial Pass/Fail: Pass Overall Compliance: No Severity Score: 2

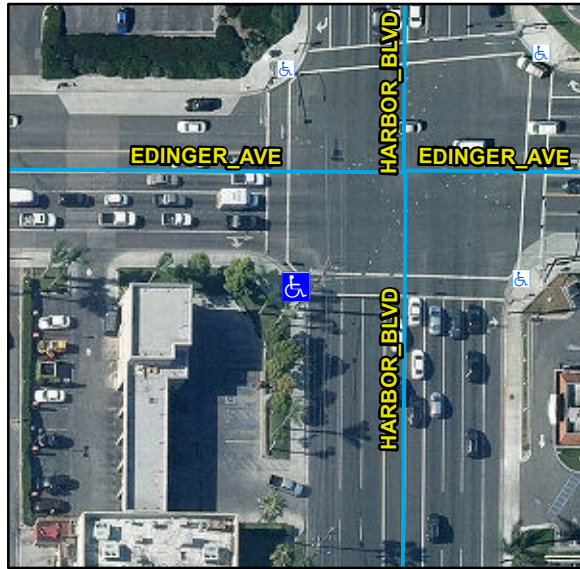
| Compliance | Description | Data | Compliance | Description | Data |
|---|---|---|---|---|---|
| No | Landing Cross Slope (%) | 3 | Yes | DWS Provided | Yes |
| Yes | Clear Space | Yes | No | DWS Offset Left (in) | 6 |
| Yes | Clear Space To Crosswalk (in) | 48 | No | DWS Offset Right (in) | N/A |

Remove & Replace Curb Ramp With Two New Directional Ramps or Equivalent.

R304.5.3, R305.2, STD 1115
