# Access Compliance Report Public Rights-of-Way (Curb Ramps)

Main Street: EDINGER\_AVE Cross Street: HARBOR\_BLV Location: NW

ADA ID: RPRK220222151948 Ramp Type: Type 1 - Perpendicular Diagonal Initial Pass/Fail: Pass Overall Compliance: No Severity Score: 0

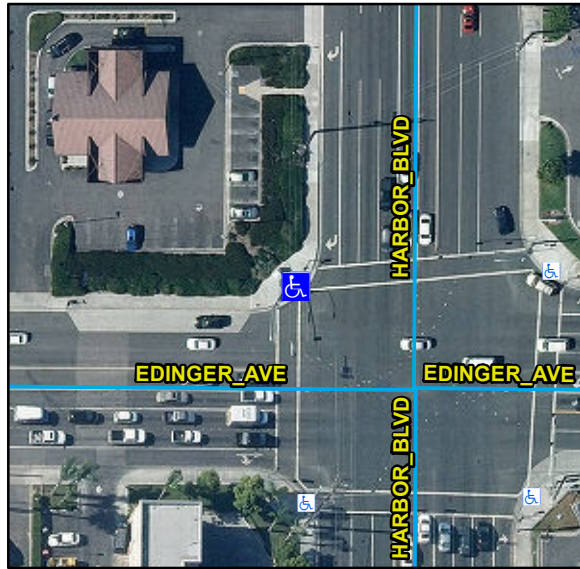
| Compliance | Description | Data | Compliance | Description | Data |
|---|---|---|---|---|---|
| N/A | Landing Present | Yes | N/A | Flare Type RT | |
| N/A | Landing Length (in) | 54 | | | Sloped |
| N/A | Landing Movement Obstructed? | Yes | Yes | DWS Contrast | Yes |
| | Landing Movement Type | Curb | Yes | DWS Length (in) | 36 |

Possible Solutions:

Remove & Replace Landing.

R304.2.1, STD 1115
