# Access Compliance Report

## Public Rights-of-Way

### (Curb Ramps)

Main Street: EDINGER\_AVE Cross Street: HARBOR\_BLV Location: NE

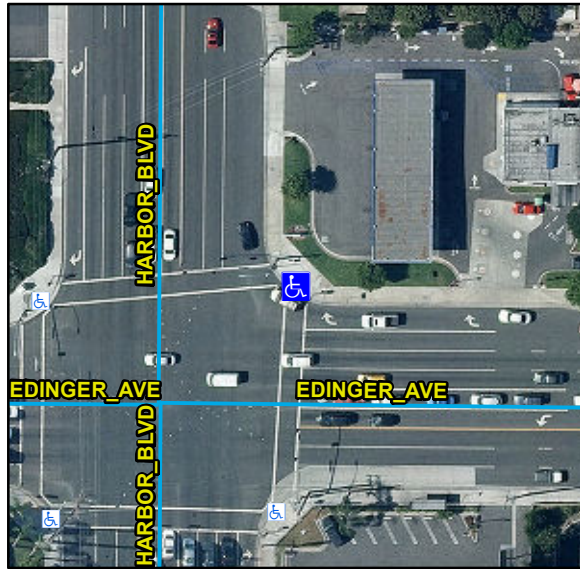
ADA ID: RPRK220222153229 Ramp Type: Type 1 - Perpendicular Diagonal Initial Pass/Fail: Pass Overall Compliance: No Severity Score: 2

| Compliance | Description | Data | Compliance | Description | Data |
|---|---|---|---|---|---|
| N/A | Landing Movement Obstructed? | Yes | Yes | DWS Contrast | Yes |
| | Landing Movement Type | Curb | Yes | DWS Length (in) | 24 |

Possible Solutions:

Remove & Replace Landing.

R304.2.1, STD 1115
