# Access Compliance Report Public Rights-of-Way (Curb Ramps)

Main Street: EDINGER\_AVE Cross Street: HARBOR\_BLV Location: SE

ADA ID: RPRK220222154642 Ramp Type: Type 4 - Parallel Initial Pass/Fail: Fail Overall Compliance: No Severity Score: 2

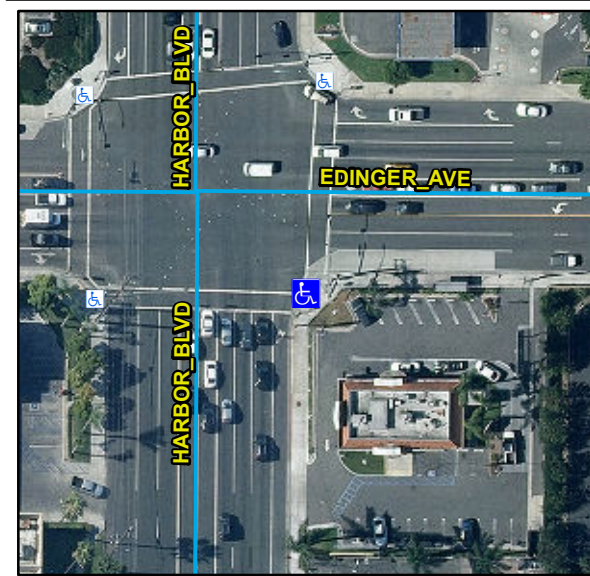
| Compliance | Description | Data | Compliance | Description | Data |
|---|---|---|---|---|---|
| No | Ramp Cross Slope LT (%) | 4.4 | No | Ramp Cross Slope RT (%) | 3.9 |

Remove & Replace Curb Ramp With Two New Directional Ramps or Equivalent.

R304.5.3, STD 1115

Total Cost: \$ 4000
