# Access Compliance Report Public Rights-of-Way (Curb Ramps)

Main Street: N/A Cross Street: EDINGER\_AVE Location: SW

ADA ID: RPRK220222162045 Ramp Type: Type 4 - Parallel Initial Pass/Fail: Fail Overall Compliance: No Severity Score: 2

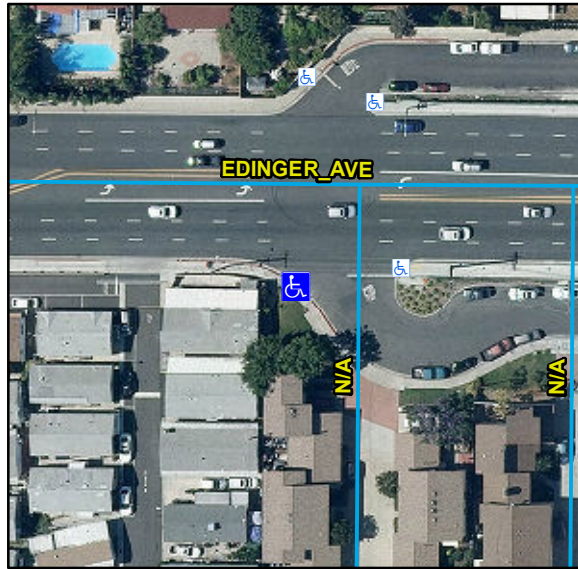
| Compliance | Description | Data | Compliance | Description | Data |
|---|---|---|---|---|---|
| No | Ramp Cross Slope LT (%) | 2.4 | No | Ramp Cross Slope RT (%) | 3.5 |

**Remove & Replace Curb Ramp With Two New Directional Ramps or Equivalent.**

**R304.5.3, STD 1115**
