# Access Compliance Report Public Rights-of-Way (Curb Ramps)

Main Street: N/A Cross Street: EDINGER\_AVE Location: SE

ADA ID: RPRK220222162603 Ramp Type: Type 7 - Directional 2 Initial Pass/Fail: Pass Overall Compliance: No Severity Score: 2

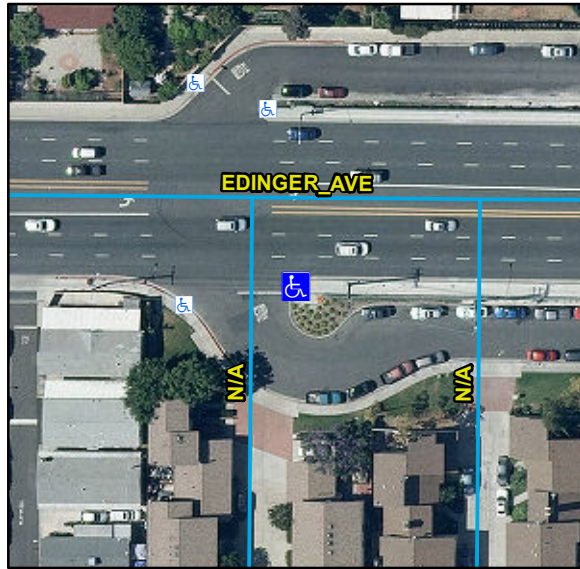
| Compliance | Description | Data | Compliance | Description | Data |
|---|---|---|---|---|---|
| No | Ramp Cross Slope (%) | 2.1 | N/A | Flare Traversable LT | N/A |
| No | Grade Break Slope (%) | 5.2 | | | Curbed2 |
| No | Landing Cross Slope (%) | 3.3 | Yes | DWS Left Offset (in) | 0 |
| No | Gutter Cross Slope (%) | 4.4 | | Parallel Ramp Side | Right |

Remove & Replace Entire Ramp. Remove & Replace Gutter.
