# Access Compliance Report

## Public Rights-of-Way

### (Curb Ramps)

Main Street: N/A Cross Street: EDINGER\_AVE Location: NE

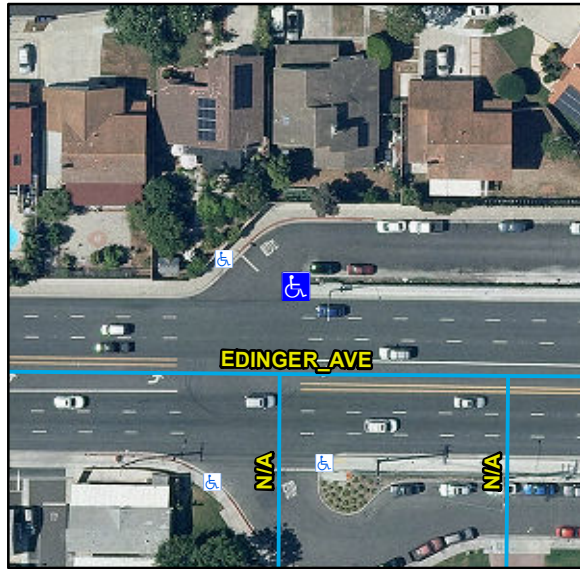
ADA ID: RPRK220222163334 Ramp Type: Type 7 - Directional 2 Initial Pass/Fail: Pass Overall Compliance: No Severity Score: 9

| Compliance | Description | Data | Compliance | Description | Data |
|---|---|---|---|---|---|
| No | Landing Length (in) | 45 | Yes | DWS Length (in) | 24 |
| No | Gutter Run Slope (%) | 7.3 | | Road Cross Slope (%) | N/A |
| No | Gutter Cross Slope (%) | 2.7 | | Parallel Ramp Side | Left |

Possible Solutions:

Remove & Replace Landing. Remove & Replace Gutter.

R304.2.1, R304.5.4, R304.5.3, STD 1115
