# Access Compliance Report Public Rights-of-Way (Curb Ramps)

Main Street: N/A Cross Street: EDINGER\_AVE Location: NW

ADA ID: RPRK220222163819 Ramp Type: Type 4 - Parallel Initial Pass/Fail: Fail Overall Compliance: No Severity Score: 16

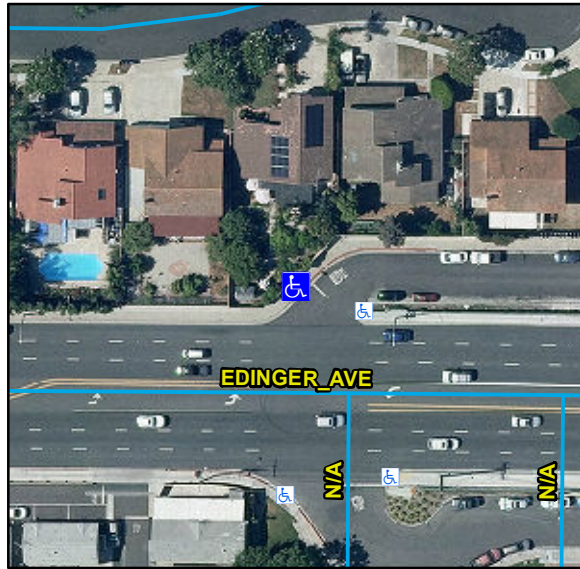
| Compliance | Description | Data | Compliance | Description | Data |
|---|---|---|---|---|---|
| No | Ramp Run Slope LT (%) | 9.4 | Yes | Ramp Run Slope RT (%) | 6.6 |
| No | Ramp Cross Slope LT (%) | 2.7 | Yes | Ramp Cross Slope RT (%) | 1.3 |

Remove & Replace Entire Ramp.

R304.3.2, R304.5.3, STD 1115
