# Access Compliance Report Public Rights-of-Way (Curb Ramps)

Main Street: N/A Cross Street: HARBOR\_BLV Location: SE

ADA ID: RPRK220222170139 Ramp Type: Type 5 - Combination 2 Initial Pass/Fail: Fail Overall Compliance: No Severity Score: 30

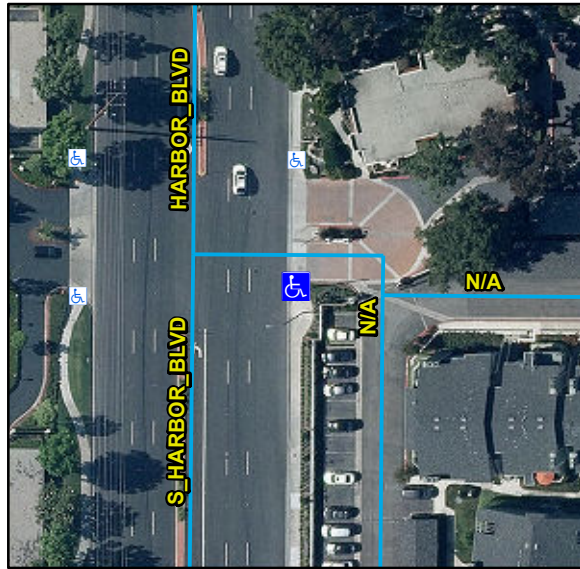
| Compliance | Description | Data | Compliance | Description | Data |
|---|---|---|---|---|---|
| N/A | Ramp Run Slope LT (%) | N/A | No | Ramp Run Slope RT (%) | 8.8 |
| N/A | Ramp Cross Slope LT (%) | N/A | No | Ramp Cross Slope RT (%) | 6.7 |

Possible Solutions:

Remove & Replace Entire Ramp.

R304.3.2, R304.5.3, STD 1115
